**City of Los Angeles
WATERSHED PROTECTION DIVISION
ENVIRONMENTAL ENFORCEMENT & EMERGENCY RESPONSE UNIT**

CASE #52967

Sunday, March 17, 2019

Spill/Fire Investigation

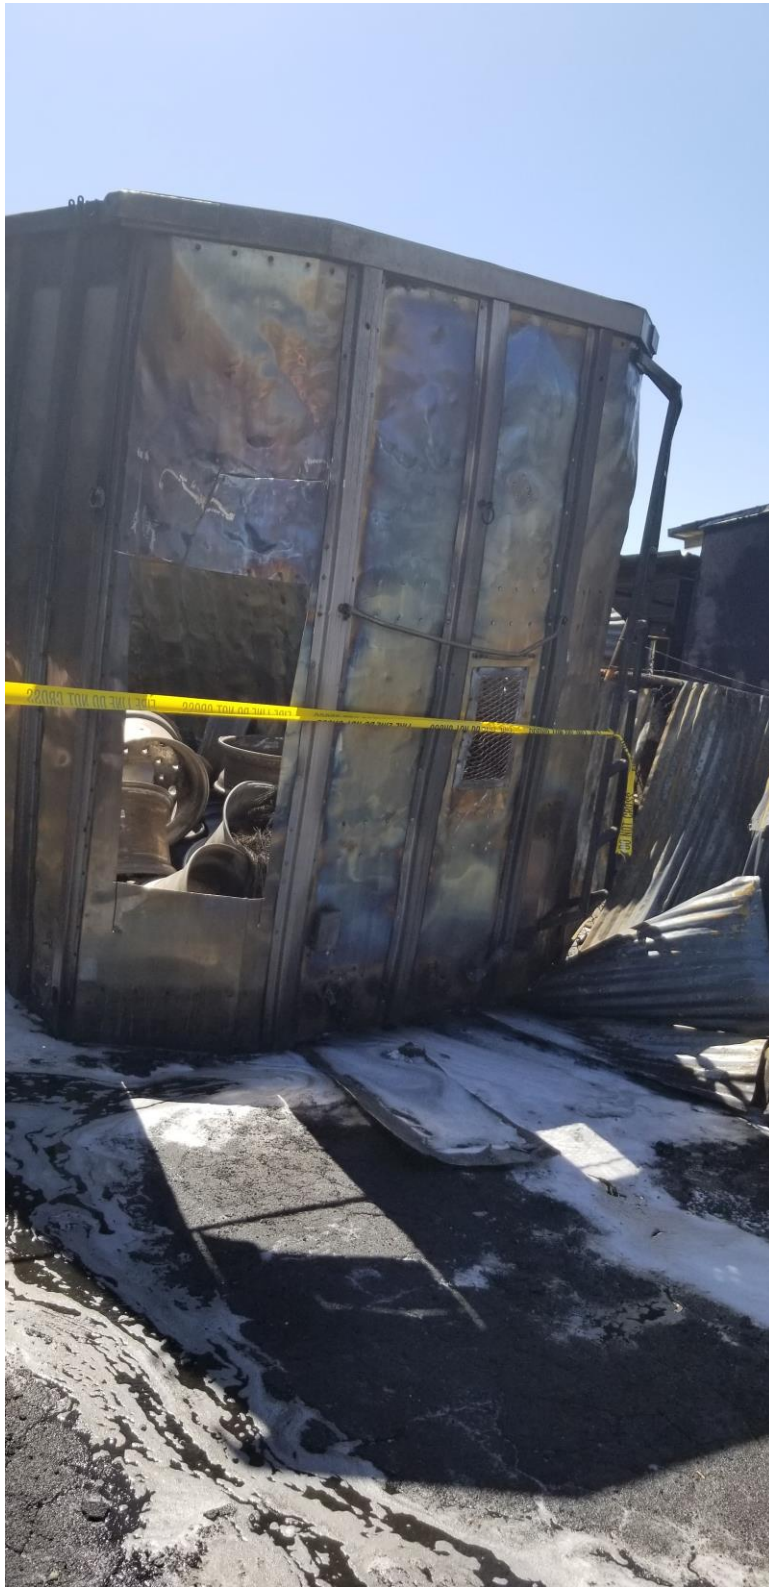
Figure #32.

View facing southwest at 210 W Slauson Ave, Parcel A, with a second fire-damaged trailer.
Ground pooling likely a mixture of fuel, water and fire retardant.

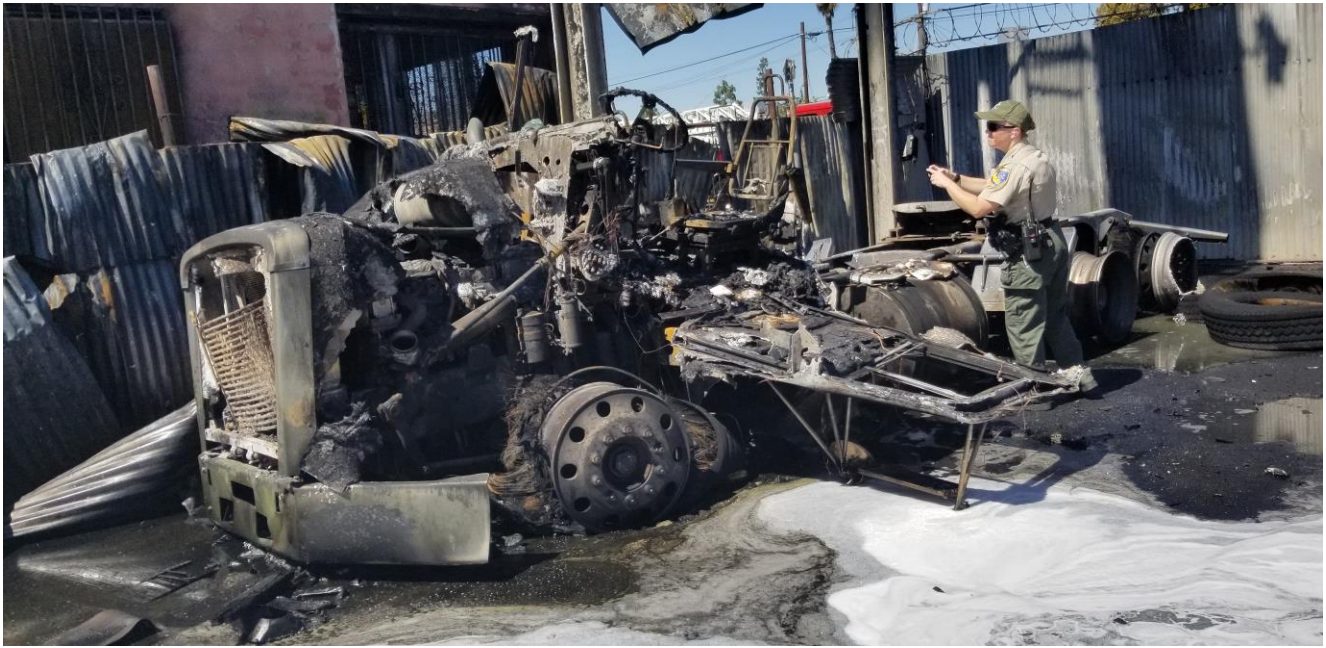
Figure #35.

View facing northwest at 210 W Slauson Ave, Parcel A, with a fire-damaged vehicle. Ground pooling likely a mixture of fuel, water and fire retardant.

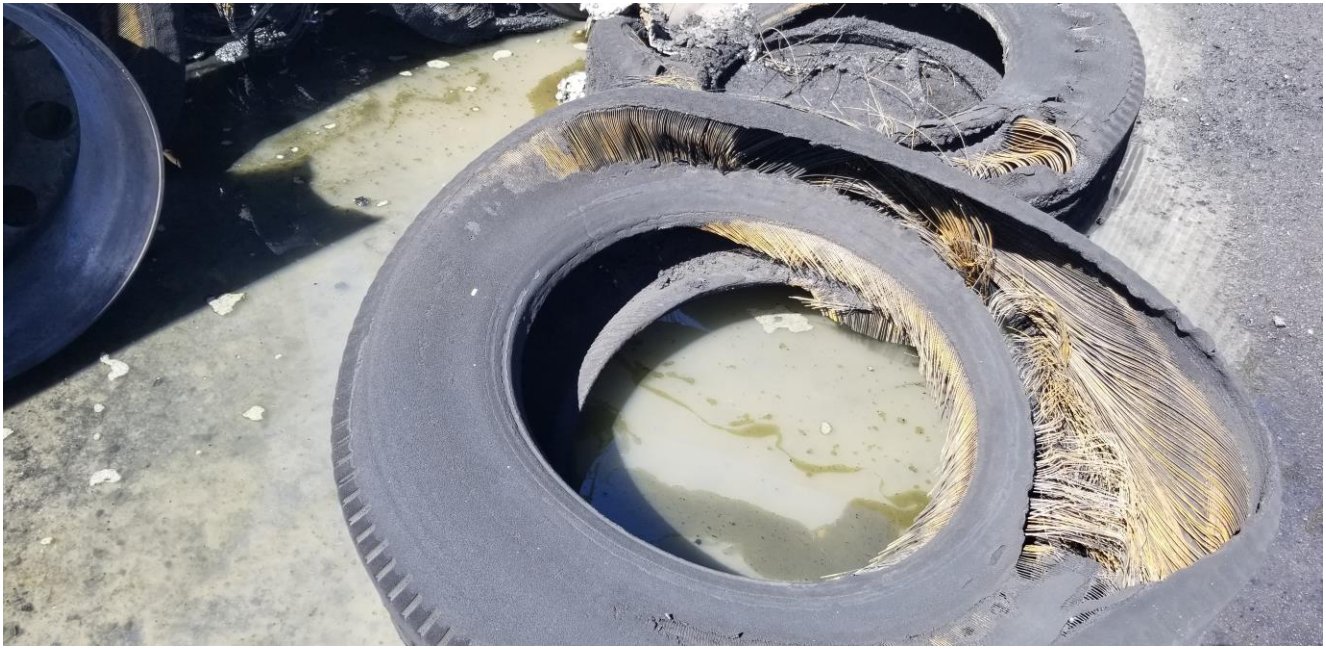
Figure #37.

Downward view of fire-damaged tires and ground near vehicle pictured in Figure 30. Ground pooling likely a mixture of fuel, water and fire retardant.

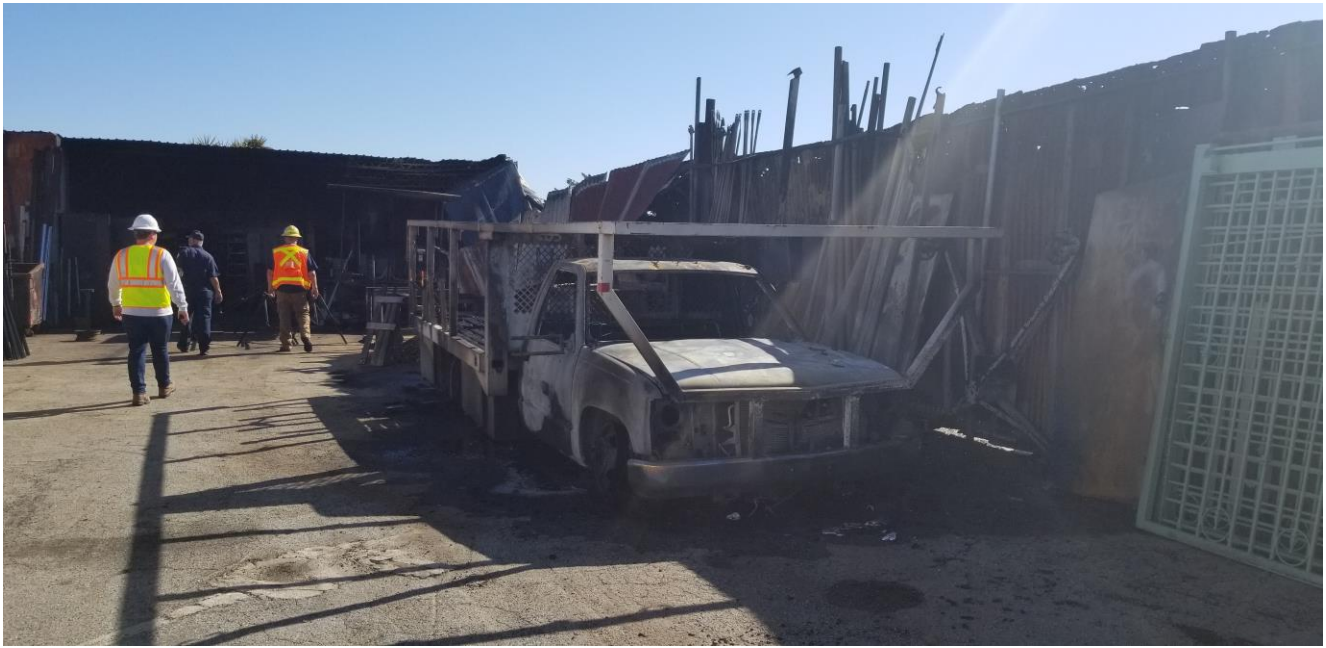
Figure #38.

View facing southwest at 210 W Slauson Ave, Parcel B, with a fire-damaged vehicle.

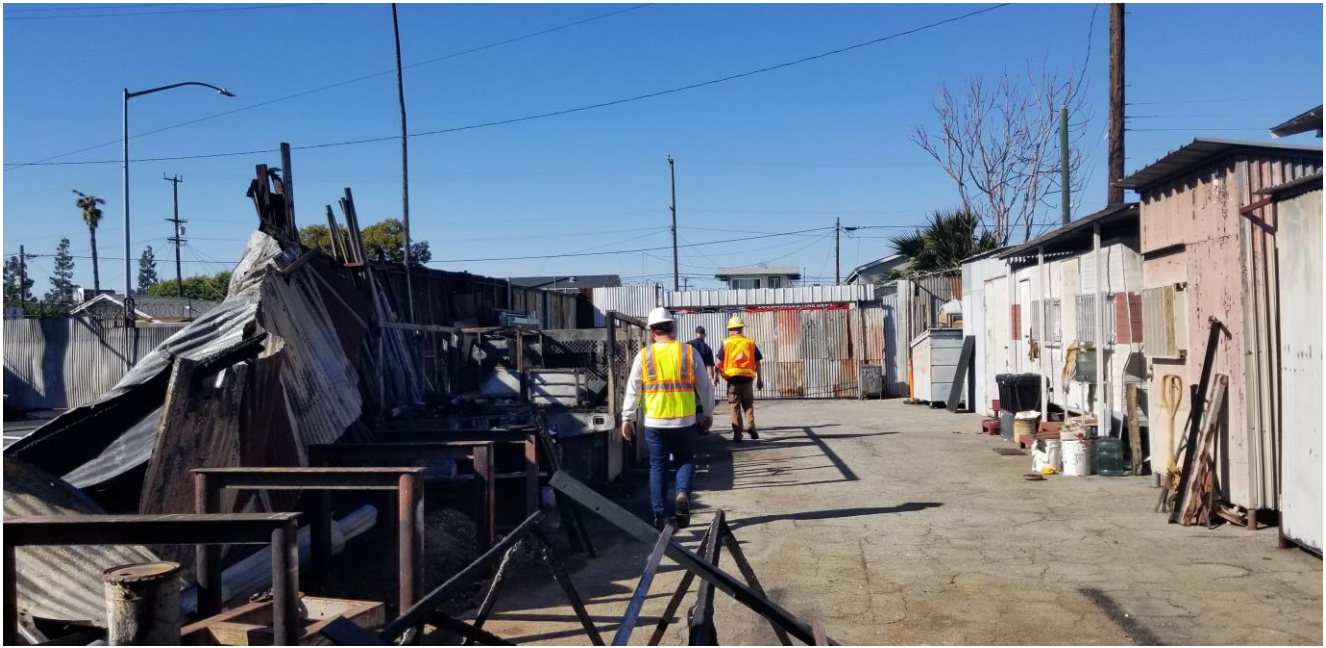
Figure #39.

View facing north at 210 W Slauson Ave, Parcel B, with fire-damaged fencing. Tenant Bryan Chun Choung's white trailer pictured on the right side of photo.

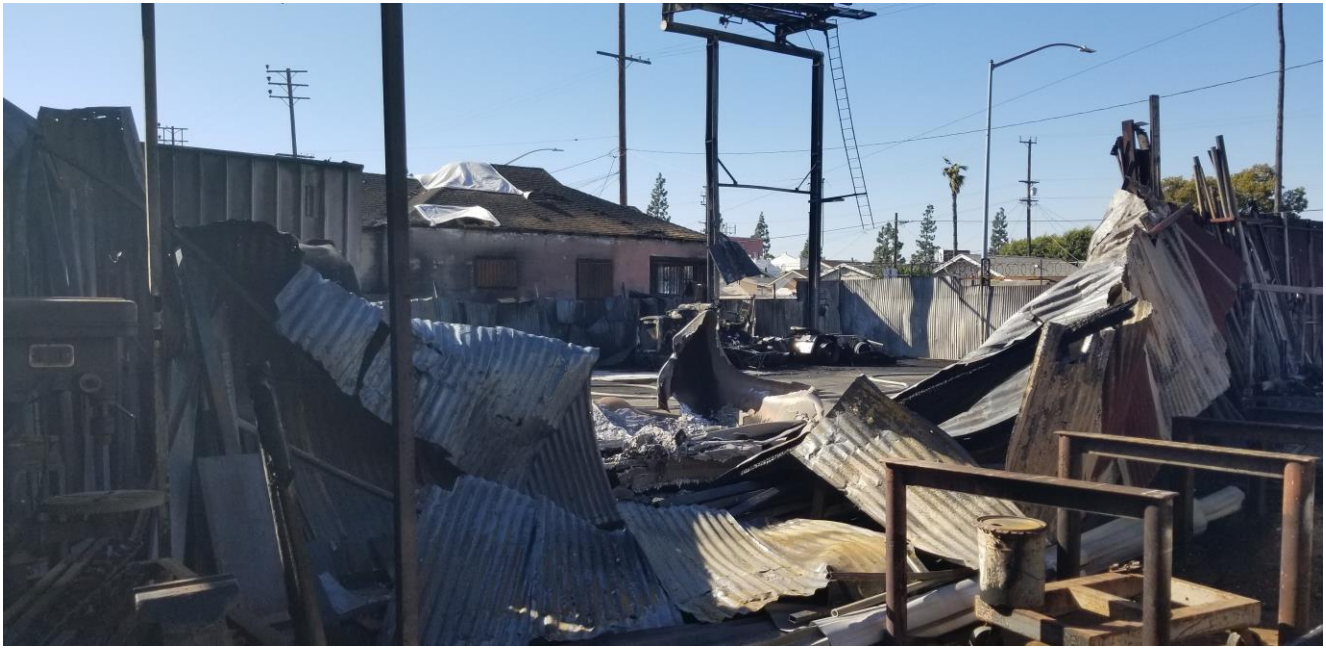
Figure #40.

View facing northwest at 210 W Slauson Ave, Parcel B, looking into Parcel A, with fire-damaged fencing that separated the two parcels.

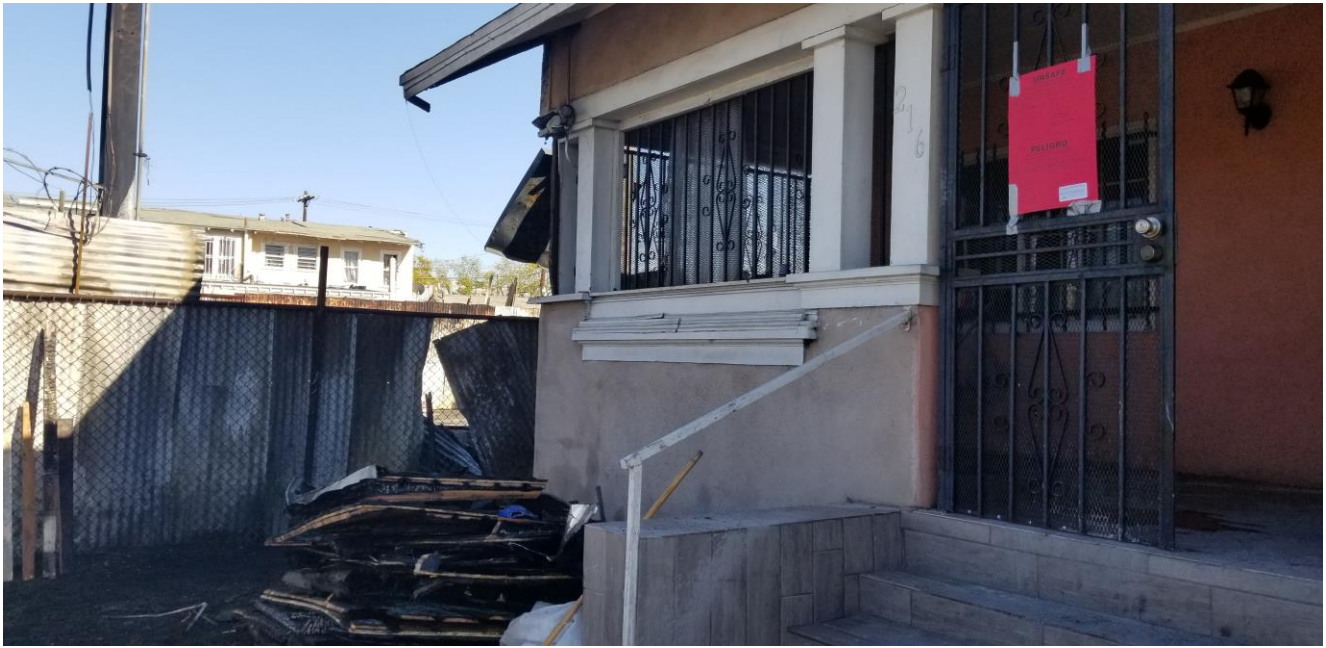
Figure #41.

View facing southeast at 216 W Slauson Ave, with fire-damaged wood on the ground. Red notice taped on door states “Unsafe, do not enter or occupy by order of the City of Los Angeles,” in English and Spanish.

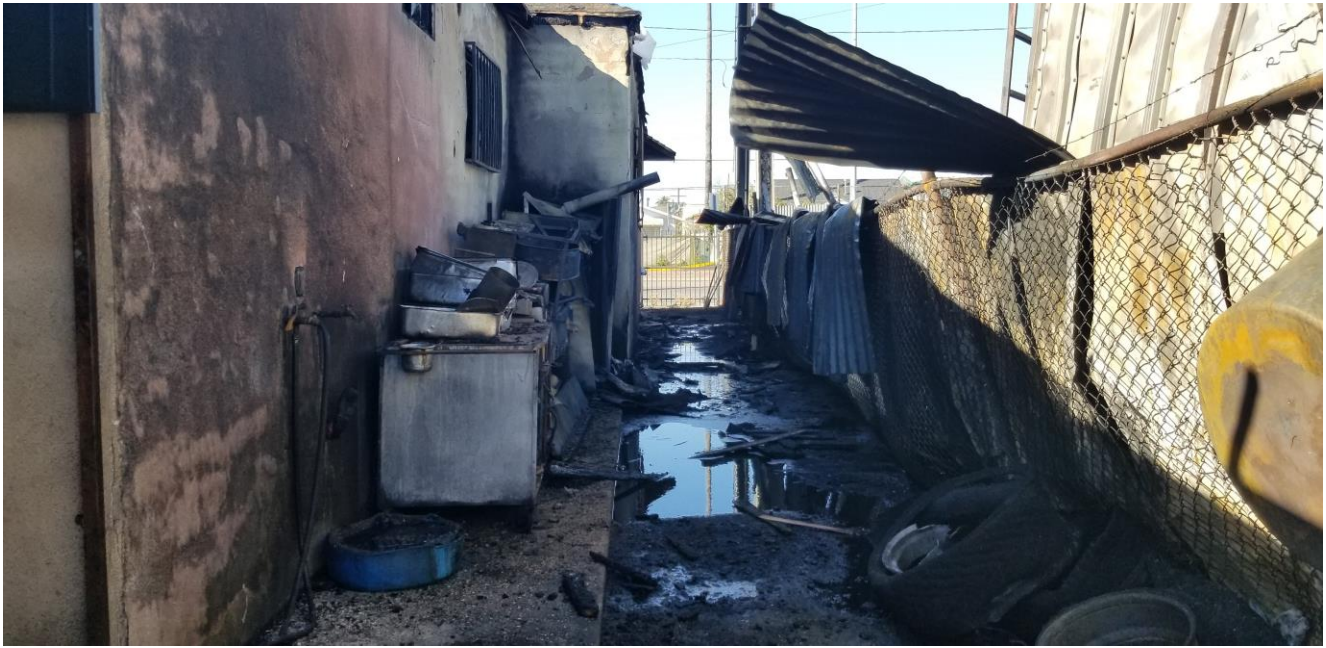
Figure #42.

View facing north at 216 W Slauson Ave, with fire-damaged fencing, walls and appliances pictured. Incident location 210 W Slauson Ave, Parcel A, is located next to this home (east of it). Ground pooling is likely a mixture of fuel, water and fire retardant.

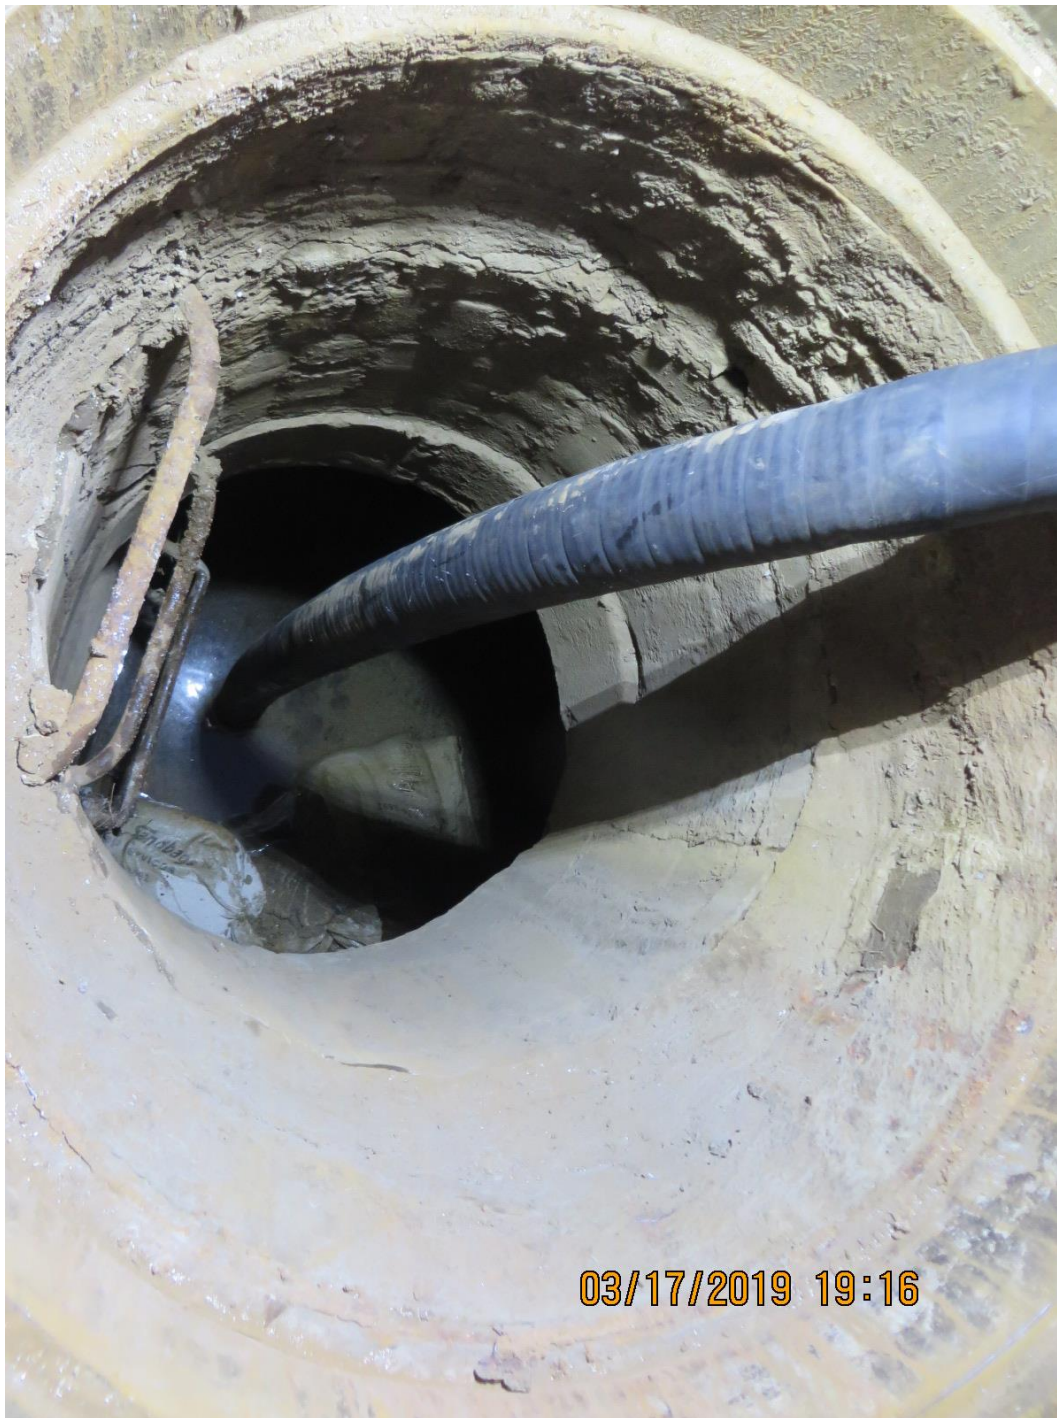
Figure #49.

Downward view inside storm drain #55705466161011 as the fuel/water mixture inside is getting vacuumed by CHES. Also pictured inside the storm drain are booms and barriers placed by CHES.

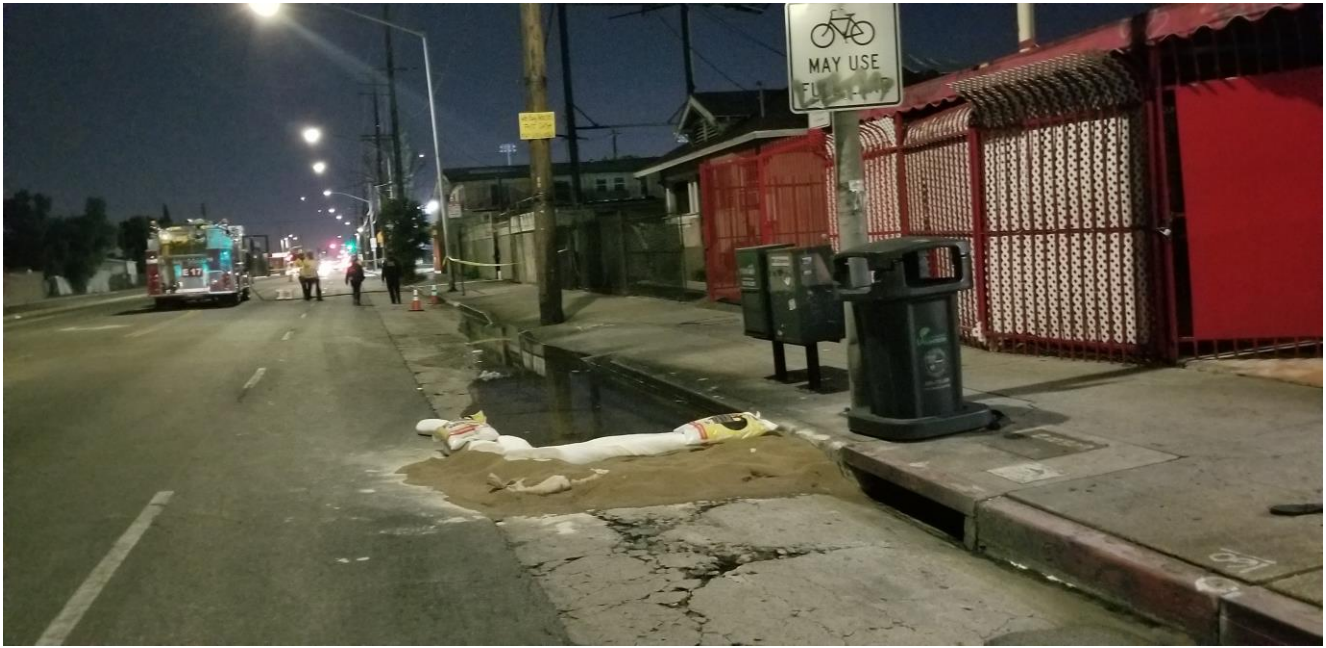
Figure #52.

View facing east along W Slauson Ave at storm drain catch basin #55701461111100 after storm drain flush operation completed. Absorbent and (likely) fuel/water/fire retardant mixture pictured was cleaned by CHES after my departure from the site on March 17, 2019.
[Photo by Cook 3/17/19]
